## ST KILDA (Museum Notes and News – February 2011)

Australian Electric Transport Museum (SA) Inc.

### W7 1013

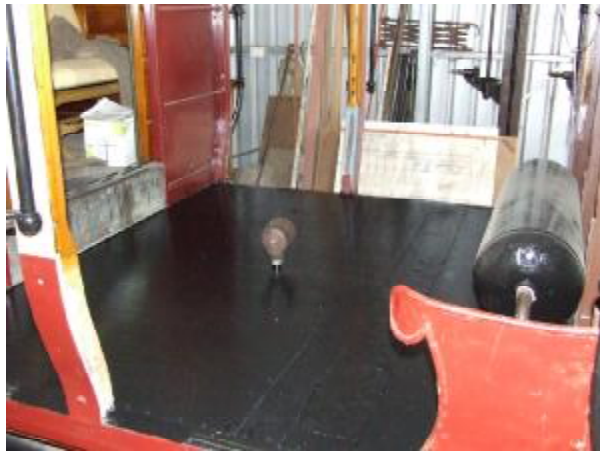
<p><i>1013 in the Road 2 Workshop on 4 December 2010 being prepared for re-entry into service after its truck change.</i></p> <p style="text-align: right;"><i>Kym Smith</i></p>
 	<p><i>The new trucks for 1013 as seen through the floor hatches on 1013.</i></p> <p style="text-align: right;"><i>Kym Smith</i></p>

Subsequently, an offer was received from the Melbourne Tramcar Preservation Association that they would make available a complete set of No. 15 trucks to enable 1013 to be returned to service. The set of trucks selected were ex SW5 843, and had been tested and operated under the tram at Haddon prior to the decision to preserve sister tram 849 that was in better body condition.

Over a number of weekends 1013 was prepared for lifting, including disconnecting motor leads, removing brake rods and removing the surplus autopoint transponder antennas to provide a clear area for the beam jacks. The replacement trucks arrived at St Kilda on Wednesday 10 November and were given a quick clean down and check over. On the following Sunday a shunt was carried out to put 1013 in the Bodyshop for lifting – 192 sharing the Bodyshop for a couple of weeks with 1013, with 14/15 being stabled over the pit in Road 2. By the end of Sunday afternoon 1013 was on the jacks and raised to almost full height.

Friday 18 November saw 1013 lifted the final few inches to enable its old trucks to be removed. The replacement set was then wheeled in and the tram lowered... only to find that the body was now leaning to one side due to unequal spring compression. 1013 was lifted again twice to try different spring combinations, and now sits reasonably level on its trucks. The following two weekends saw the motors reconnected, replacement brake long rods installed. A check of the wool led to a decision to replace all wool in the trucks to ensure longevity. 1013 was put through its paces doing five test trips on Friday 3 December, and now just needs final cleaning and tidying up before it can return to service. 1013's original trucks will now be assessed to determine their suitability for overhaul as spare trucks for 1013. Our thanks to the Melbourne Tramcar Preservation Association and to VicTrack for making the trucks available.

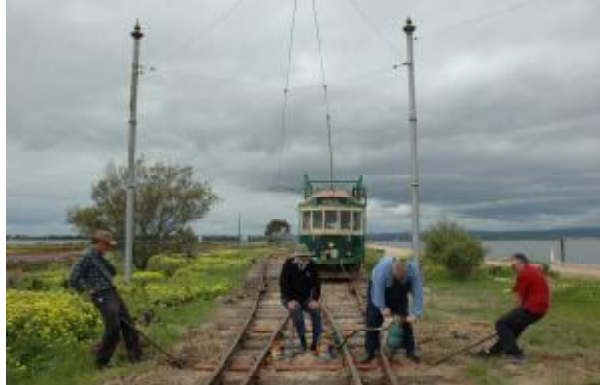
<p><i>The spring-compensating towbar installed between 14 and 15. Keen-eyed observers will also note that most of the temporary resistor banks that were on the cab floor of tram 15 are no longer there, as they are now permanently installed under the trams.</i>  <i>Kym Smith</i></p>

Work has continued on the Bib & Bub set, primarily being focused on completing the permanent connections of 14 and 15. A spring-compensating towbar has been located and installed, reducing the stress between the two trams when under severe braking. Now that testing has confirmed the values of resistances, the grids are now being installed in their permanent locations under both trams. Four new air reservoirs have been installed and the compressors on both trams made operational. Emergency valves have been installed that activate the brakes should the air connection between both trams fail. Flooring is now almost complete in both trams, and work is progressing on installing and connecting in a line breaker. The set now operates both electrically and pneumatically from both leading cabins, with both trolley poles now connected allowing the correct pole operation.
