## ST KILDA (Museum Notes and News - May 2008)

**Australian Electric Transport Museum (SA) Inc.**  
PO Box 213, Salisbury, South Australia 5108

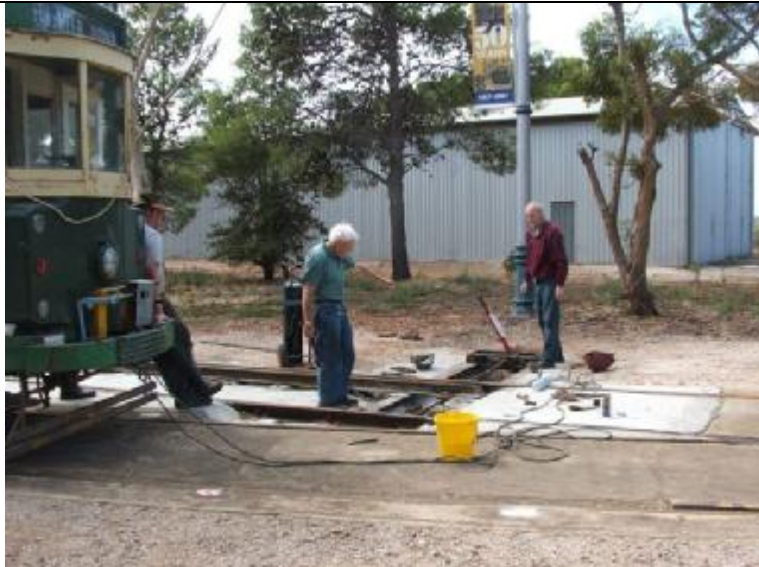
Chris Summers  
01 AETM May

Ian Seymour, Michael Crabb and Bruce Lock installing the points leading from the main line to Roads 4, 5 & 6 in concrete on Friday. 22 February 2008.

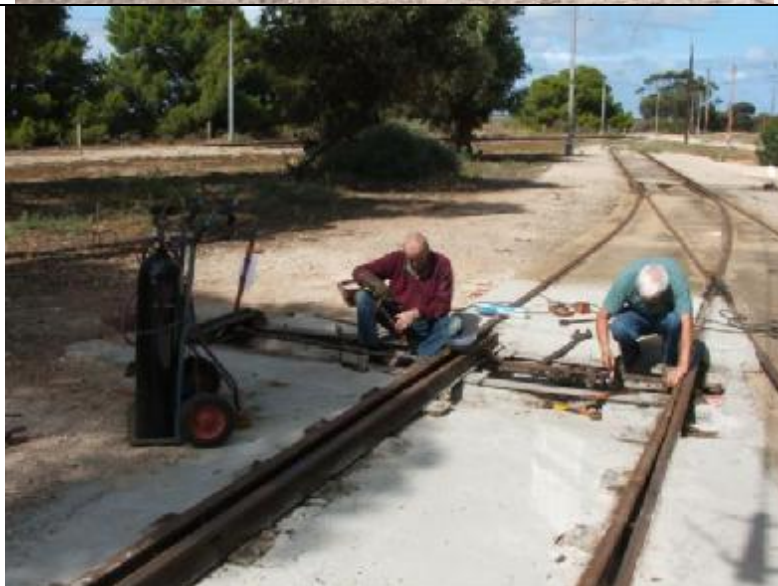
Chris Summers  
02 AETM May

Bruce Lock and Michael Crabb working on the points. The task involved re-connecting the old rodding, bolting the stand to mild steel channel spacers, then welding the spacers to the new cross rails.

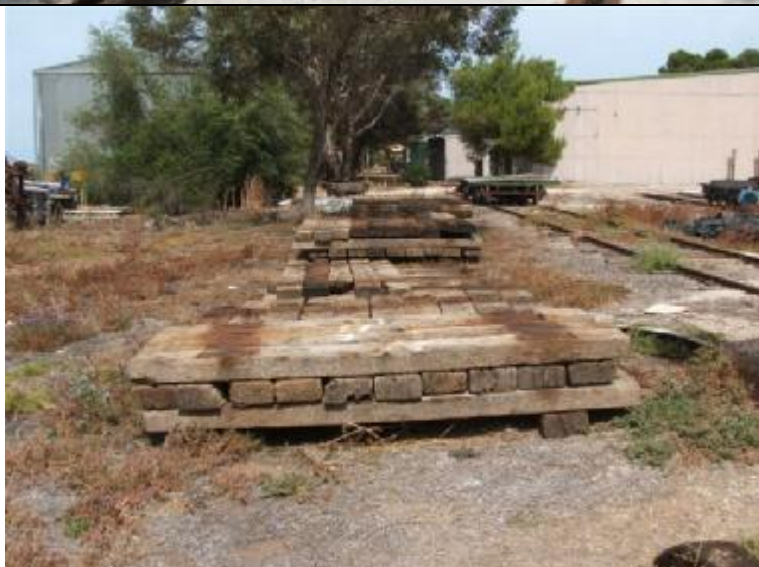
Chris Summers  
03 AETM May

As well as the 'Friday Gang', some other members do get involved. Andy Hall, on a recent visit stacked and colour coded tram line sleepers according to their condition.

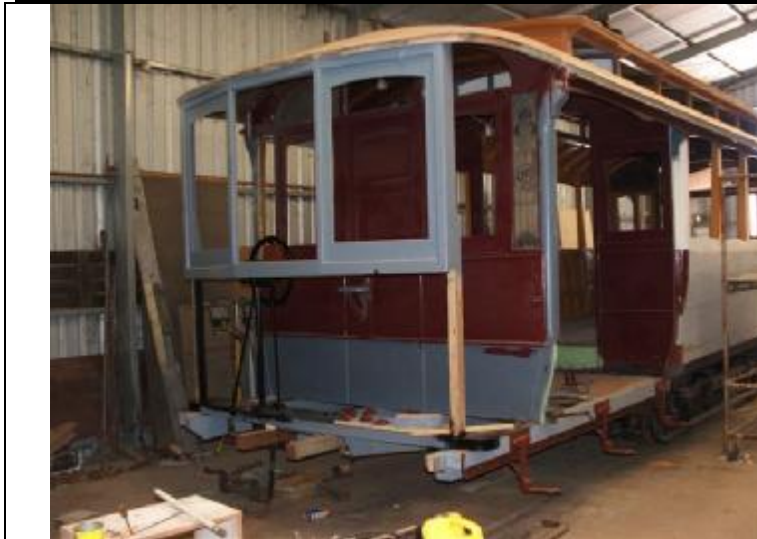
*Chris Summers  
04 AETM*

*This photo was taken on 25 January 2008. It shows car 14 a few days before installation of its K35JJ controller.*

Andy Hall lent Jack Pennack a hand with the installation of a refurbished K35JJ controller on the motorman's end of A 14. The air brake and hand brake with its associated mechanism has also been installed. Mike Bosworth has continued rebuilding the side frames at the drop-ends. Most of the new timber side frames have been bolted on and step supports are in place. Before the final side frame can be re-attached, a replacement angle iron side support will be required as the original one shows distortion due to accident damage, and is severely corroded.

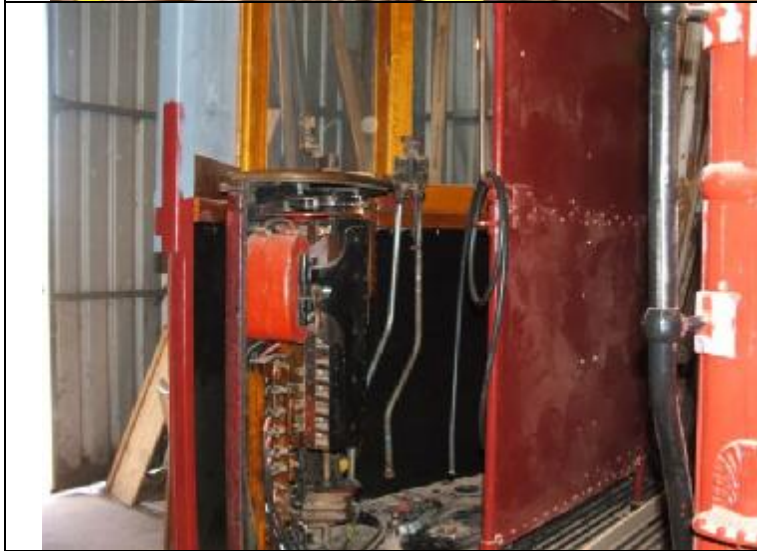
*Chris Summers  
05 AETM*

*This photo shows car 118 with the GE B23 controller obtained from Victoria and installed 3 years ago, along with a brake valve installed in February 2008.*

Bruce Lock and Mike Crabb have continued to work on the air brakes for E 118. The motorman's brake valves have been refitted to the cabs. The whole system has been pressure tested from the workshop air supply including a 'brake test' of the cylinder. An emergency valve for the conductor will be installed under a cross bench seat (not originally on E cars) to avoid the conductor having to walk the boards to the driver's cab on the open section in the event of an emergency.
