ST KILDA (Museum Notes and News - November 2008)

Australian Electric Transport Museum (SA) Inc.

Bib and Bub Project

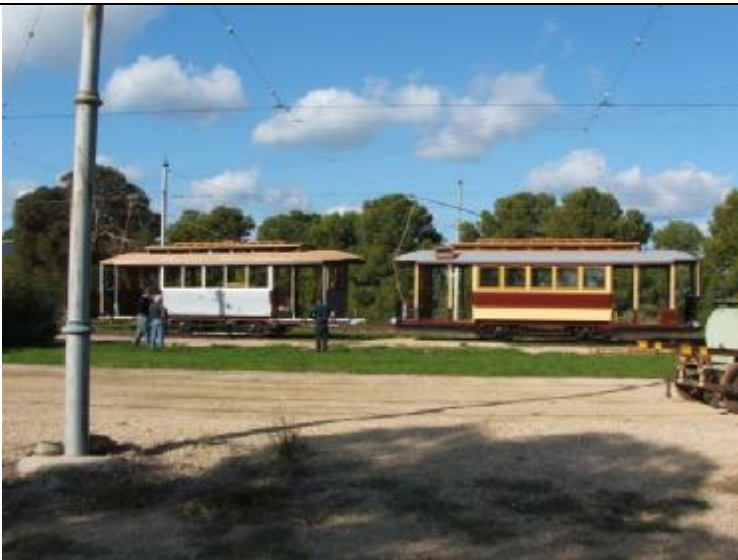
<p>Bib & Bub cars 14 and 15 meet in June 2008. Chris Summers 01 AETM Nov</p>

Bib tram A 14 has returned to the bodyshop after successfully completing its trial runs. There is still a considerable amount of work to complete the restoration of this tram. Jack Pennack has made a start by refitting the double sliding doors and their chain-drive equalising mechanism to the saloon.

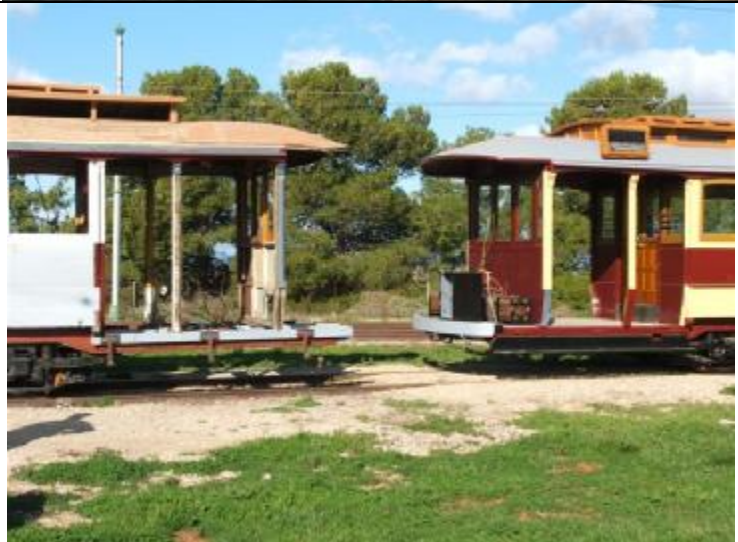
<p>Bib & Bub cars 14 and 15 showing the ends which will eventually be coupled. Chris Summers 02 AETM Nov</p>

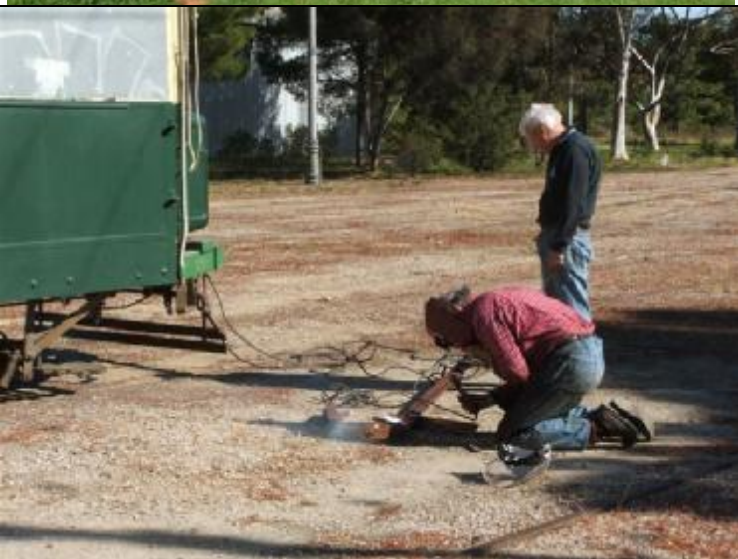
<p>Bruce Lock and Michael Crabb making a replacement beam for attaching the brake shoe pull off springs for one of 118's trucks, September 2008. Chris Summers 03 AETM Nov</p>

While Bruce Lock and Mike Crabb have been busy refitting the Brill 22E trucks with their brake rigging, Jack Pennack revarnished the original ceiling panels ready for reinstallation in the crossbench section of car 118.

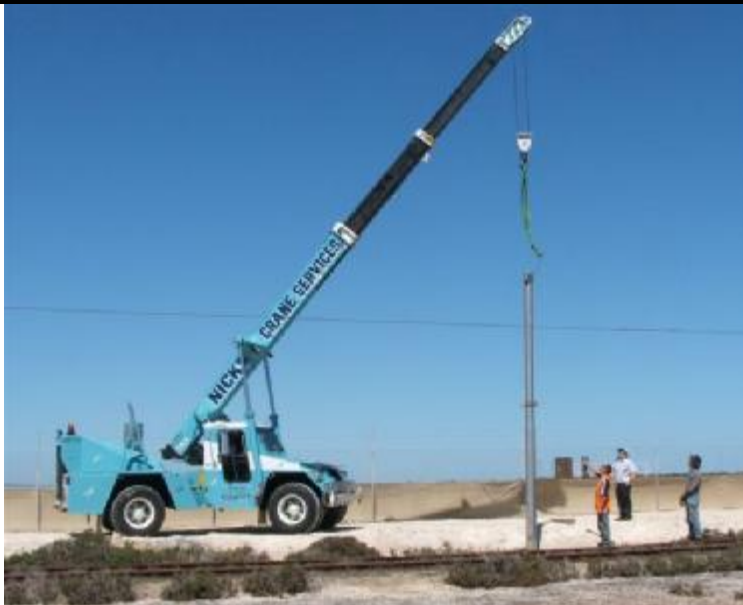
Chris Summers
04 AETM Nov

Andy Hall and Michael Bosworth watching a replacement pole being put in place on the lakeside track.

Poles 10 and 24 have been replaced. These pole replacements were organised by Mike Bosworth and the Friday gang. Preparatory work has commenced on the first of the two poles at Mangrove Loop to extend their life span. This will involve welding collars onto the poles where they are being eaten out by rust caused by the salt air. These centre poles are historical as they are former King William Street Poles.

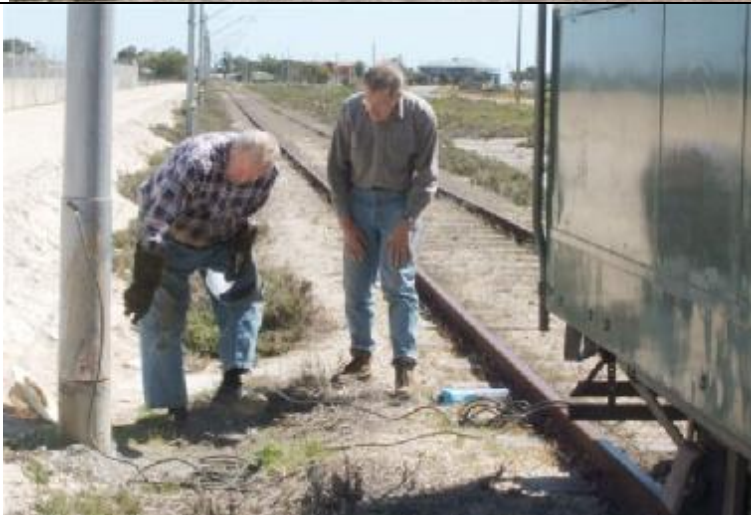
Chris Summers
05 AETM Nov

Bruce Lock preparing to weld the pole into position watched by Michael Bosworth.

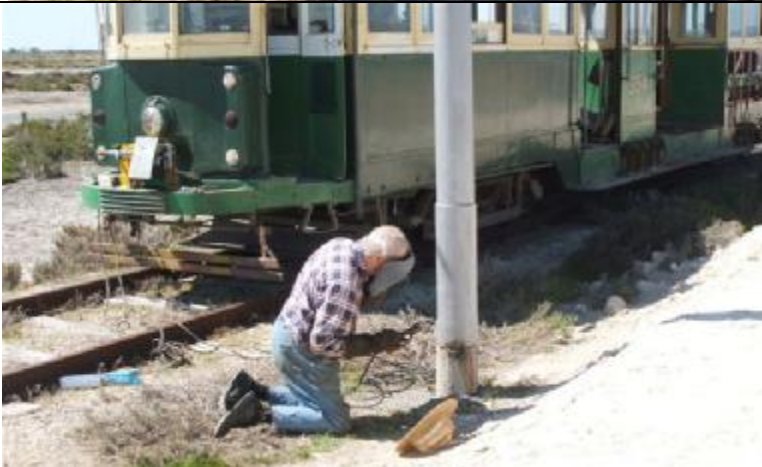
Chris Summers
06 AETM Nov

Bruce Lock welding the pole. Works car W2 354 provides the power.
